## 8300FP AXION MSR™ COMBINATION EYE / FACE WASH & DRENCH SHOWER Freeze Proof

**Model 8300FP Axion Eye Wash & Shower Freeze Proof** No.2080163/1

## Model **8300FP Axion** Eye Wash & Shower Freeze Proof No.2080163/1

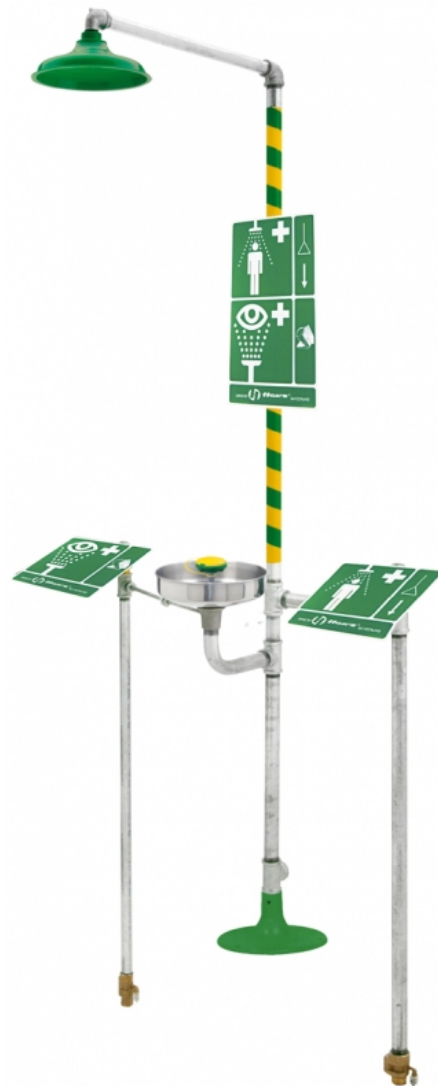
- ✓ 1 1/4"G / 3/4"G
- ^ 1 1/4"G
- Ⓛ 34 kg
- ♿ No
- Ⓢ CH
- Ⓩ Z535.1

- AXION MSR™ shower head (SP829)
- Combination emergency shower & eyewash sign (SP178).
- Floor flange (SP75)
- 1" Freeze proof valve (MK8A)
- 1 1/4" freeze proof valve (MK81A)
- Single motion push plate, for freeze-resistant valves MK8A und MK81A (SP218)
- Check valve for freeze-resistant valves MK8A und MK81A. (SP82)
- Eye / face shower head (SP65CTFP)
- Test tag (SP170)
- 11" catch basin (SP90)
- High visibility stripe (SP185)
